# Redevelopment Overview

## Jeparit Weir Replacement

Hindmarsh Shire Council

28 February 2026

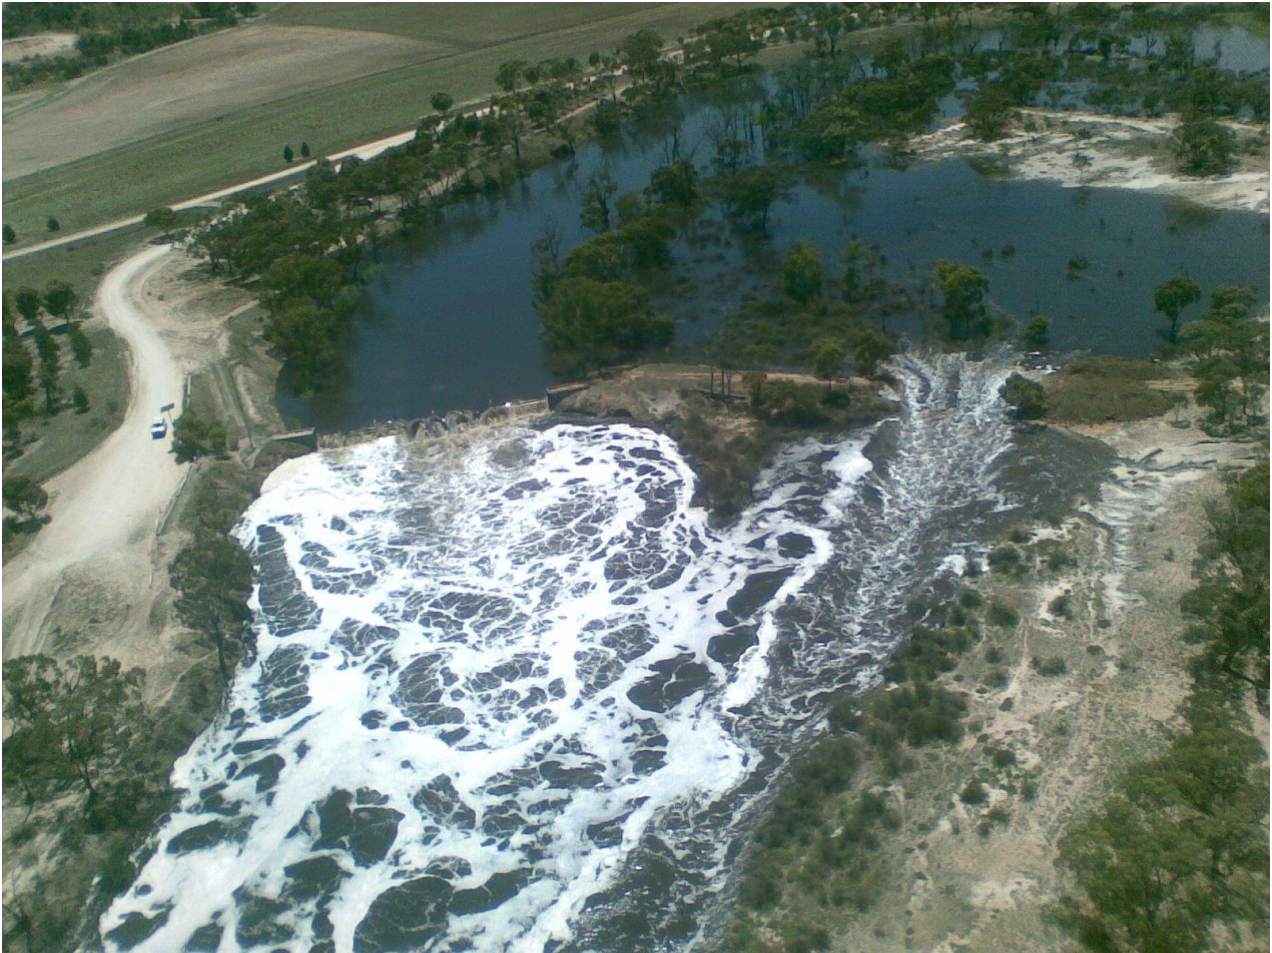
This event did cause major damage to the Jeparit weir which was repaired a year later. A photo taken during the 2011 flood event that displays the overtopping of the weir is shown in Figure 4-3. The image above also shows a breakout to the right of the weir which is where a new spillway was developed following the event.

**Figure 4-3** Overtopping of the Jeparit weir during the 2011 flood event

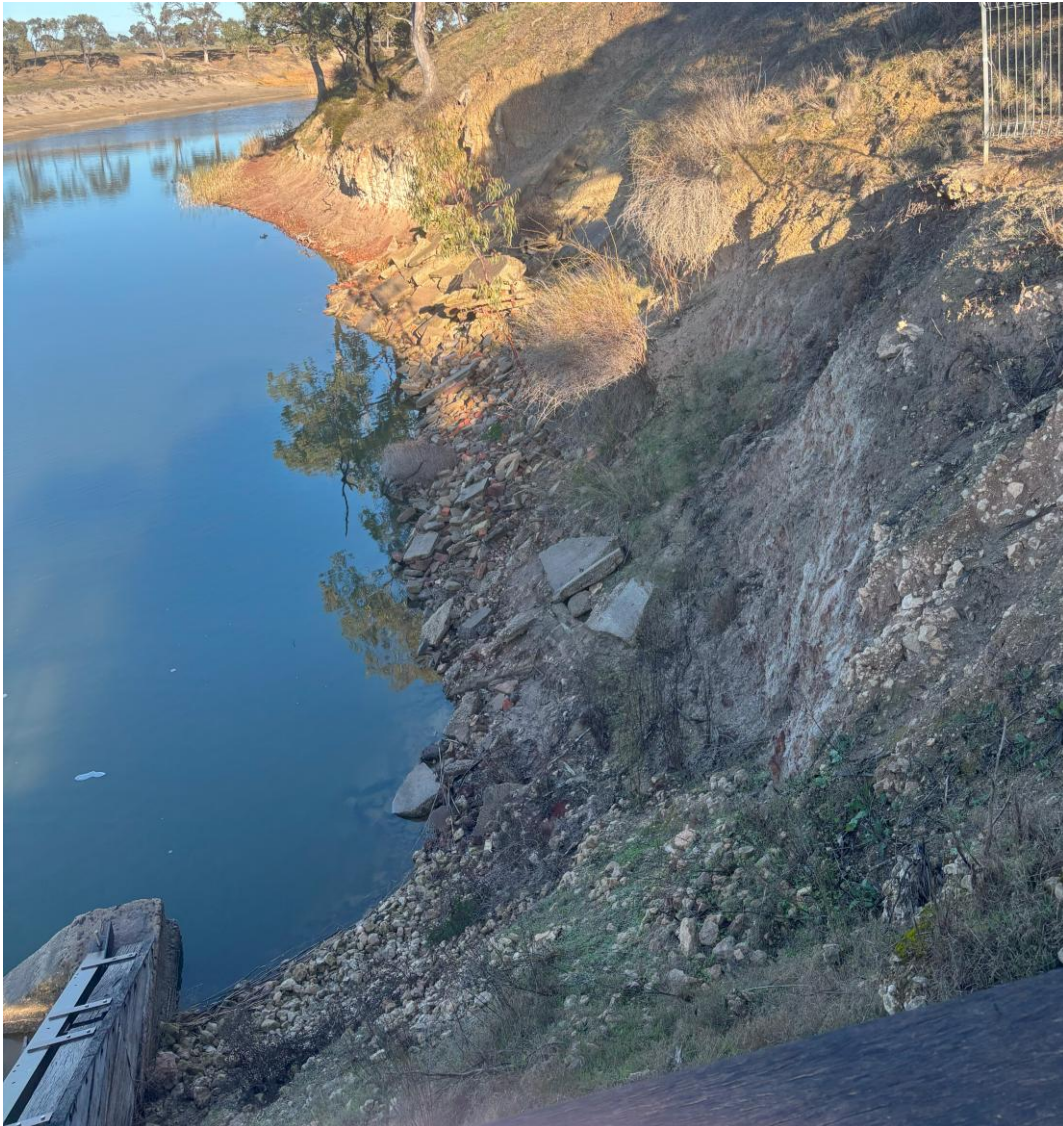
**Photograph 3 – Right abutment immediately downstream of the weir.**

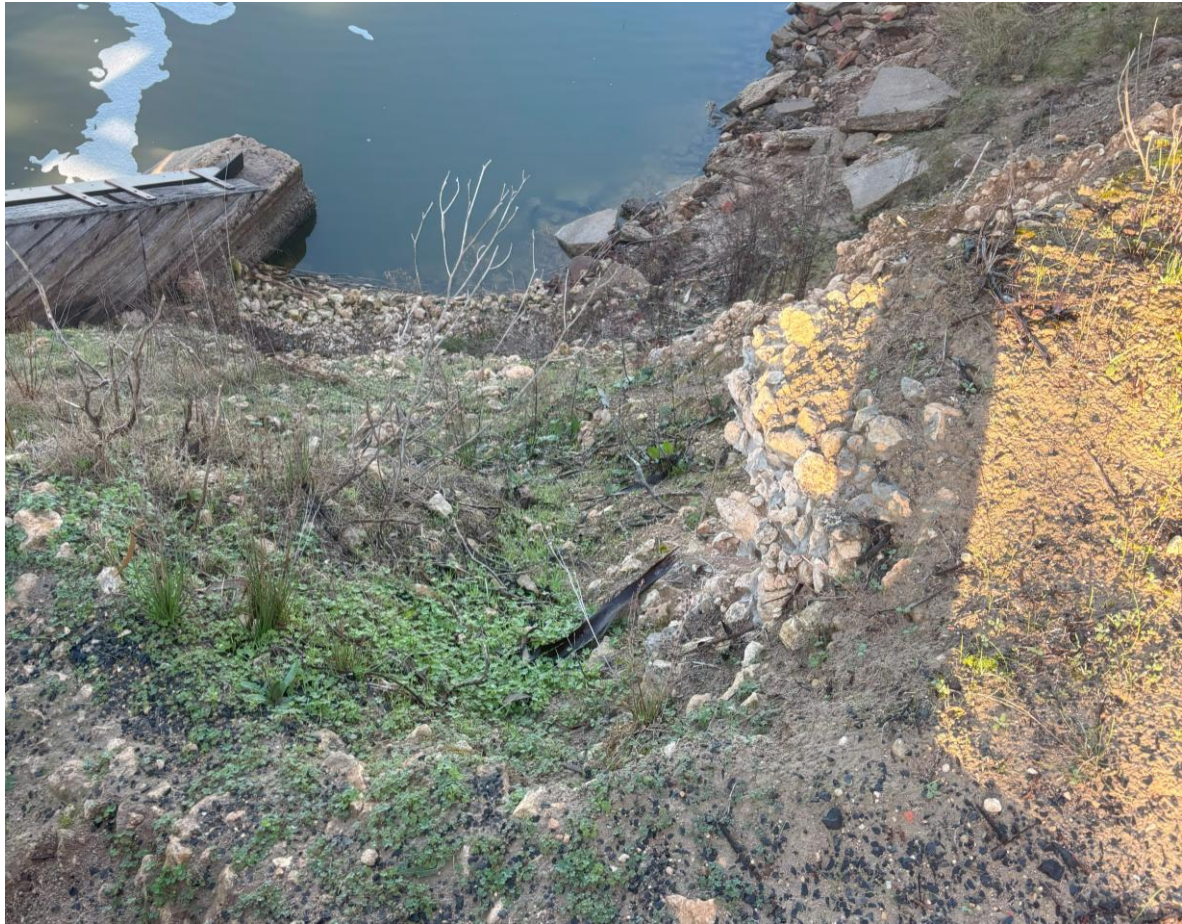
**Photograph 4 – Downstream end of the RHS retaining wall.**

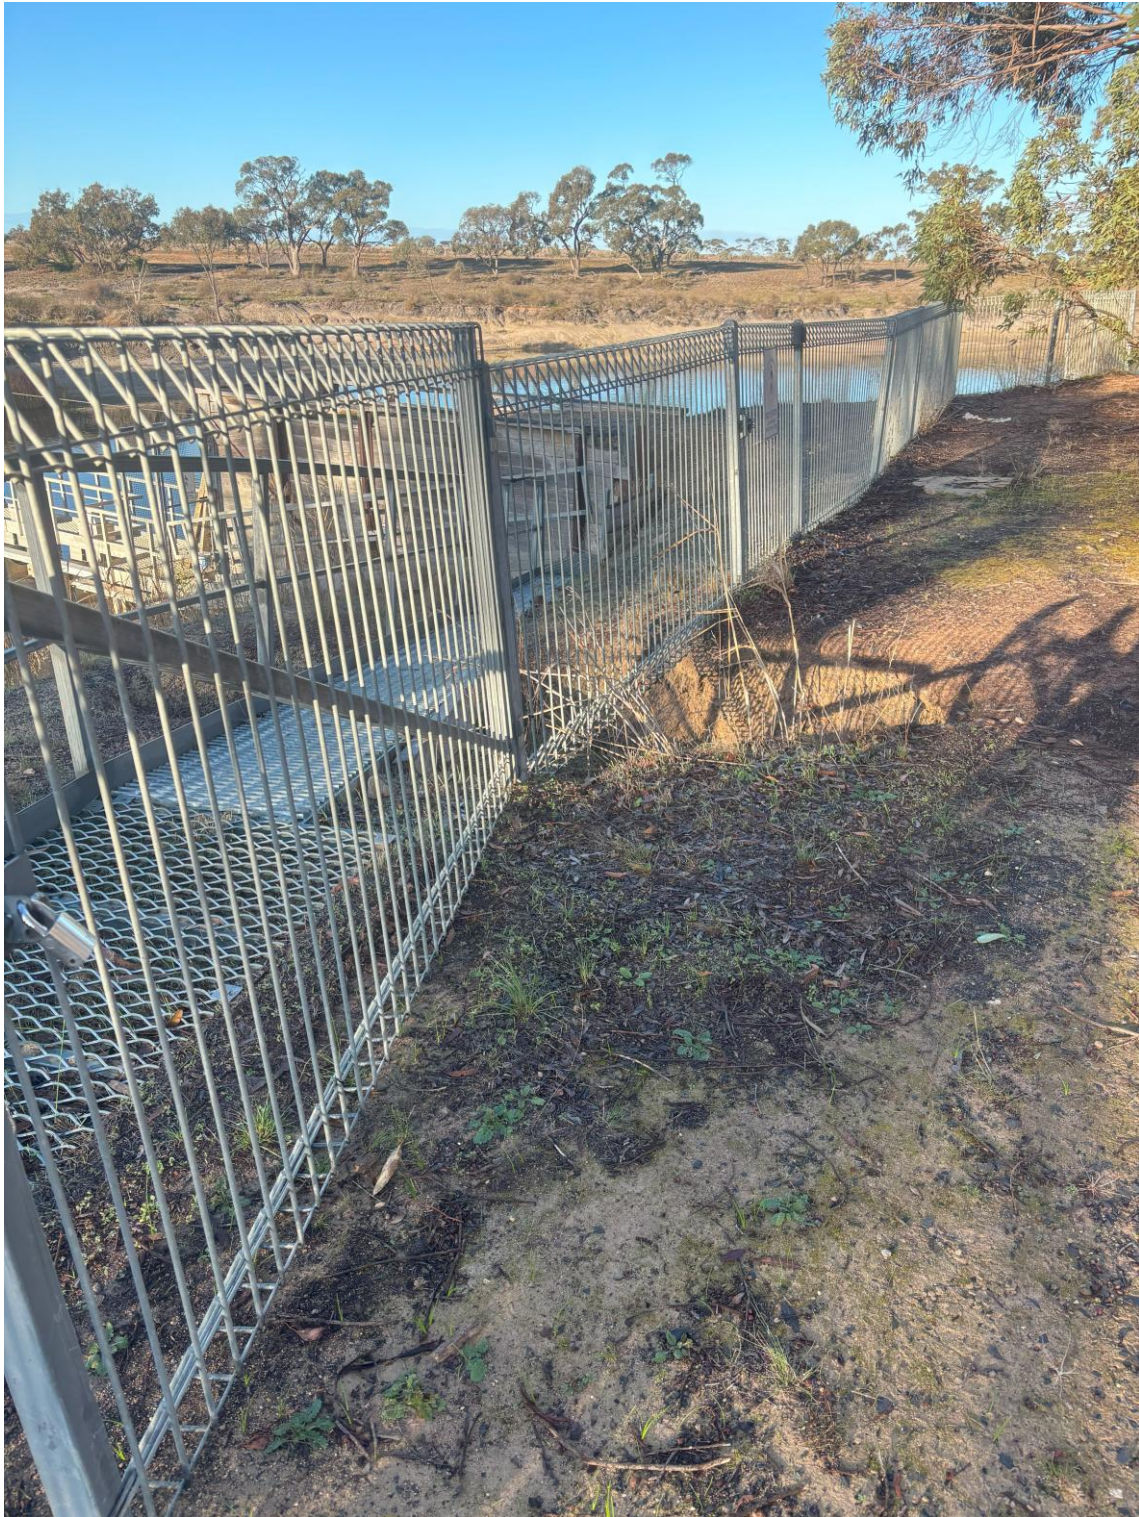
**Photograph 5 – Erosion along entry fence line**

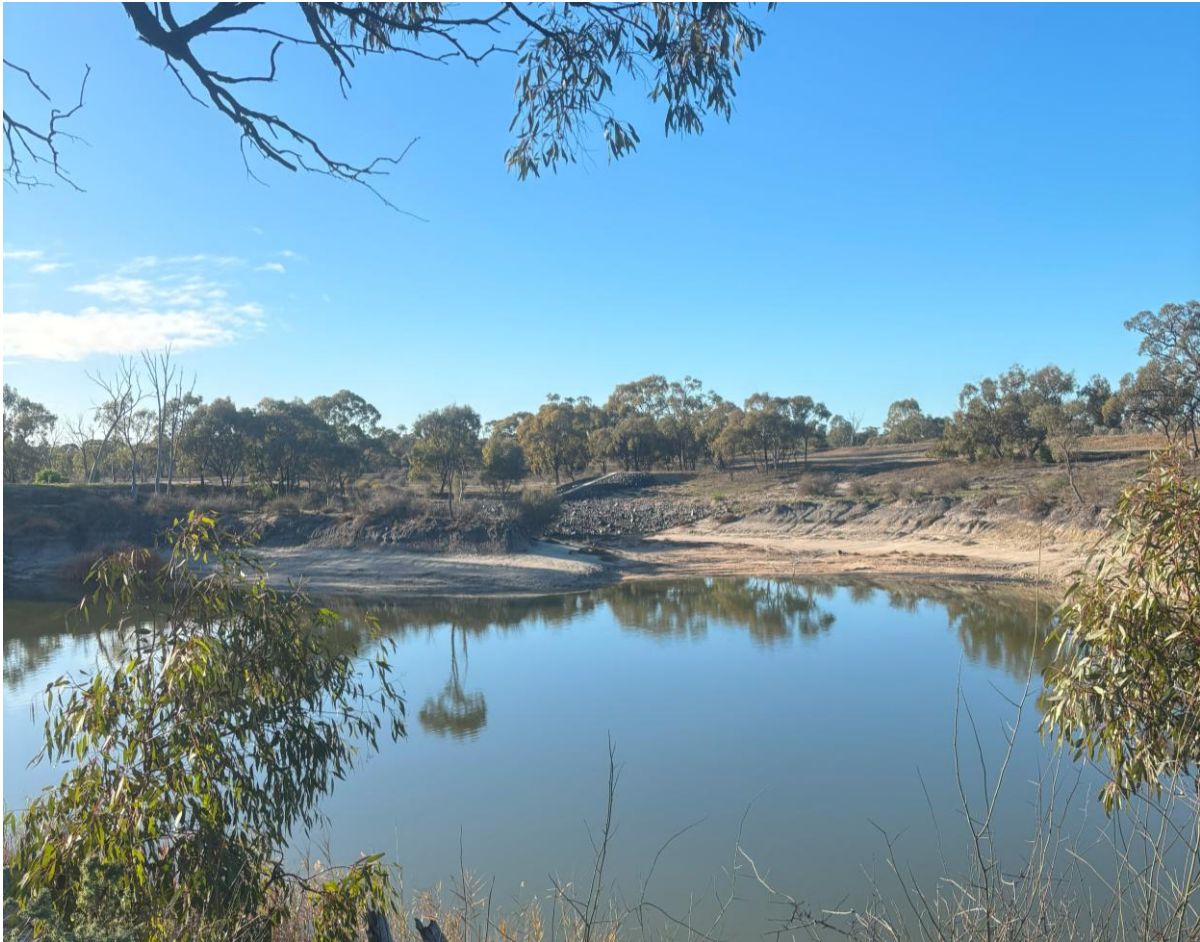
**Photograph 6 – Spillway on downstream left side of river.**

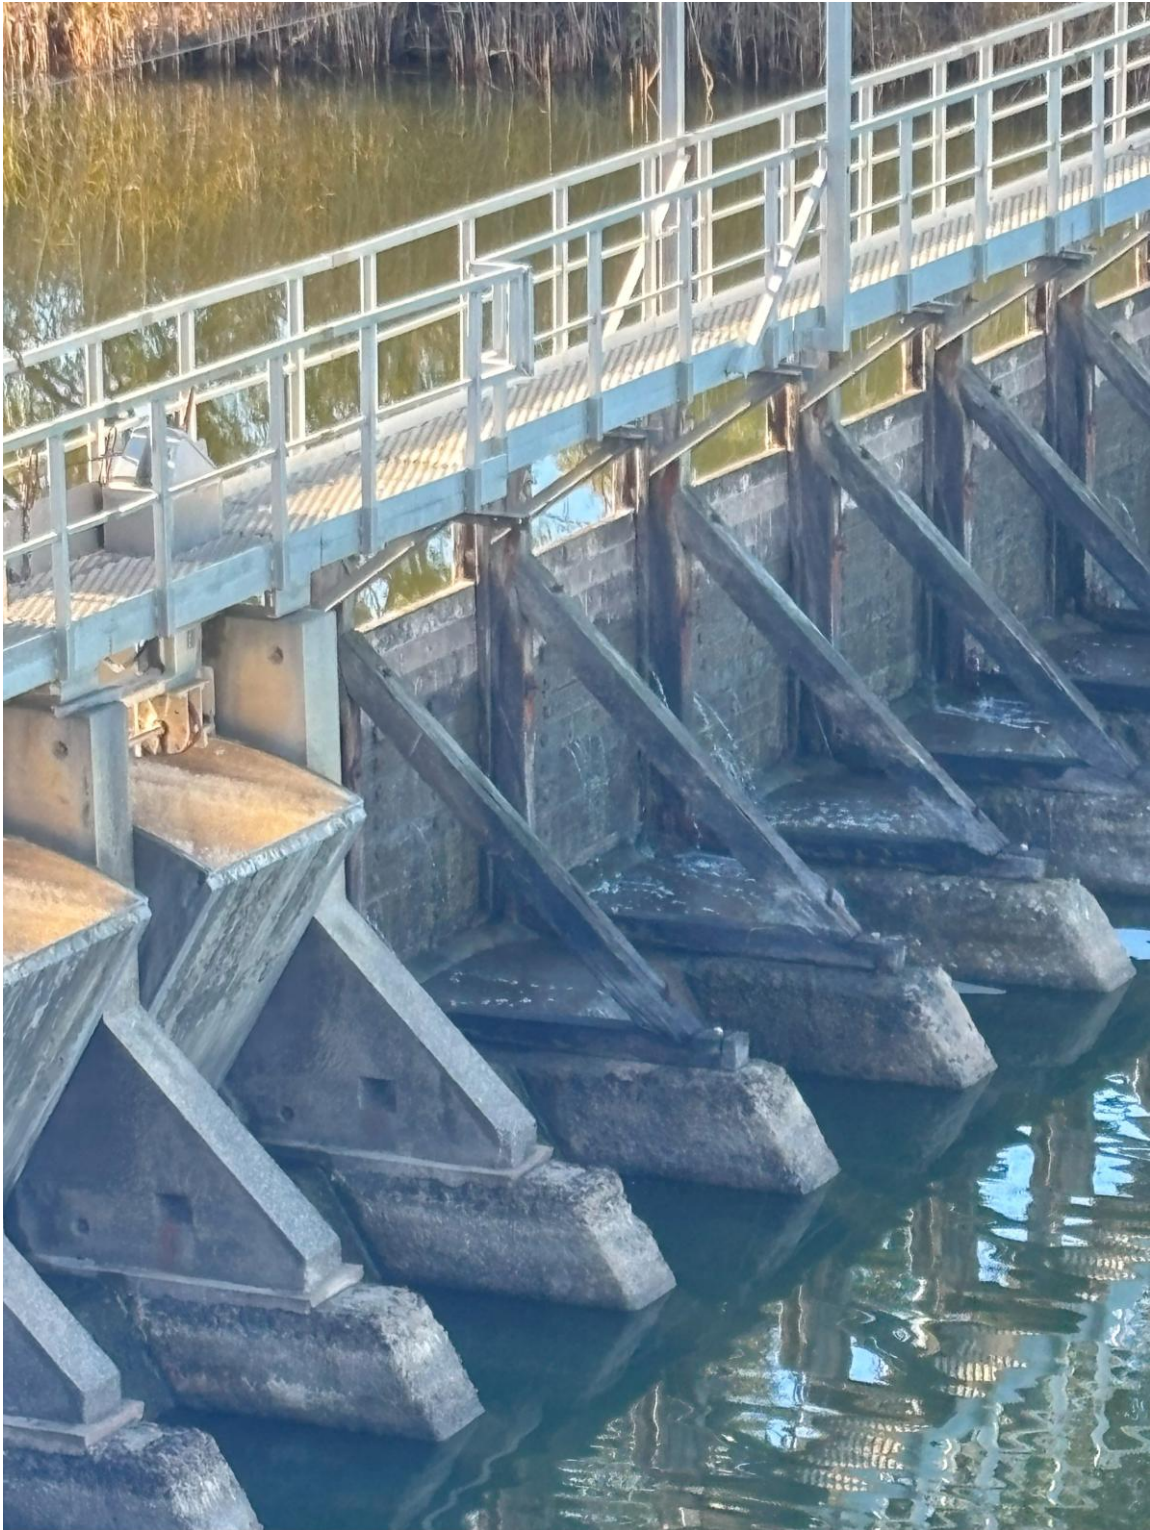
**Photograph 7 – Weir boards downstream.**

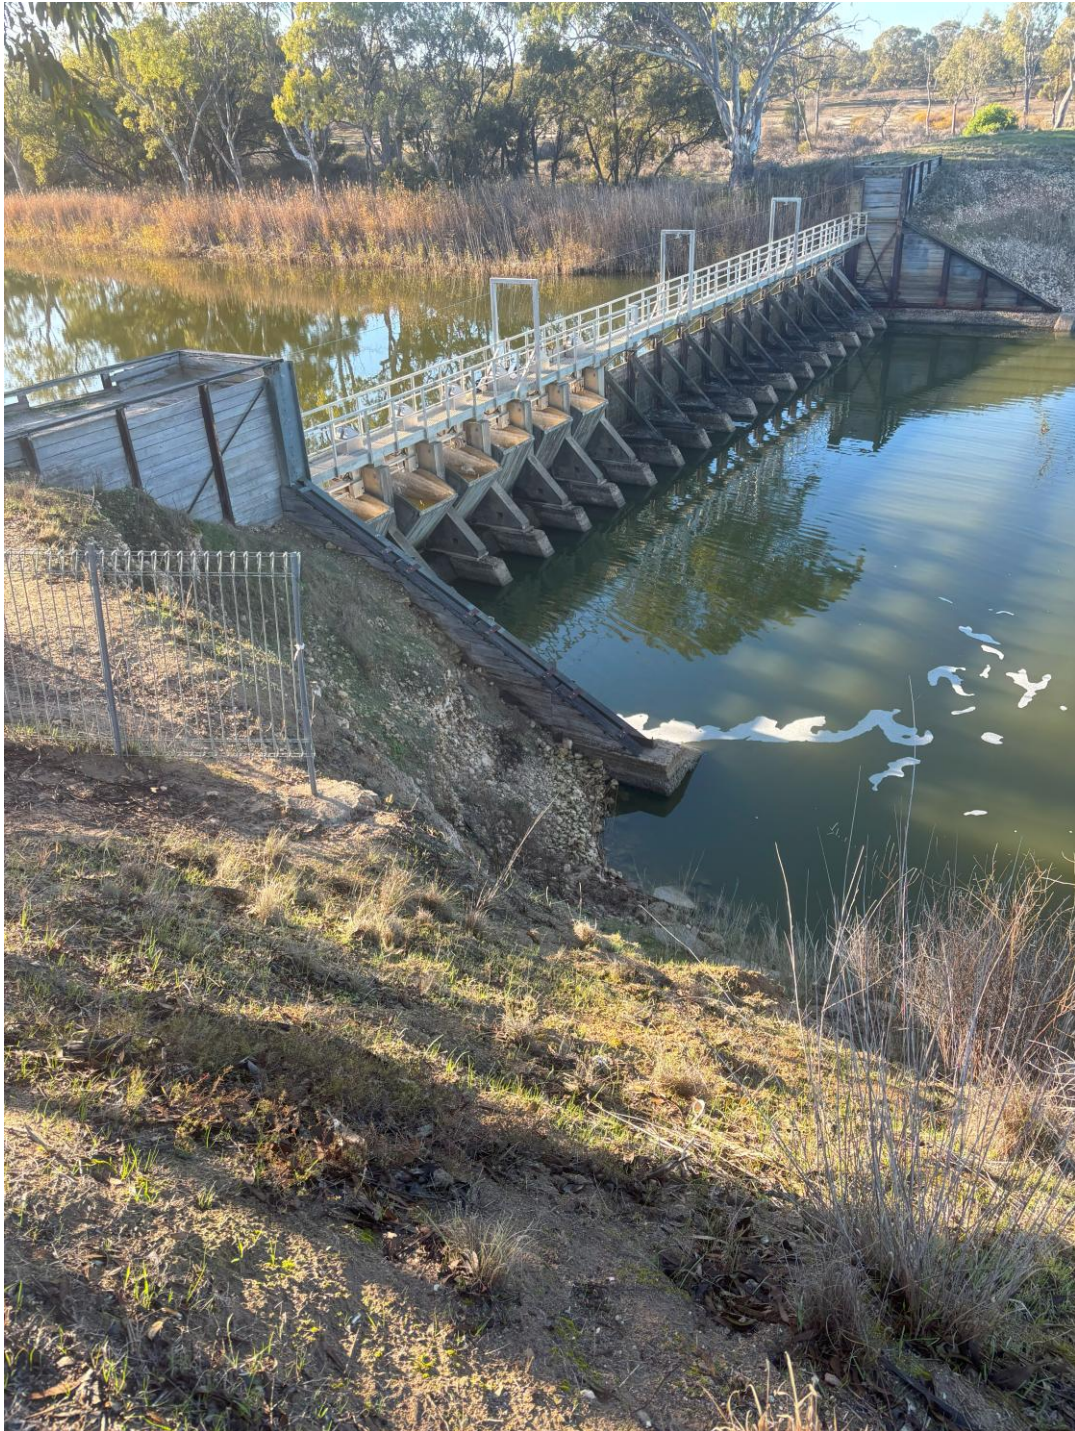
**Photograph 8 – Right side abutment downstream of the weir.**

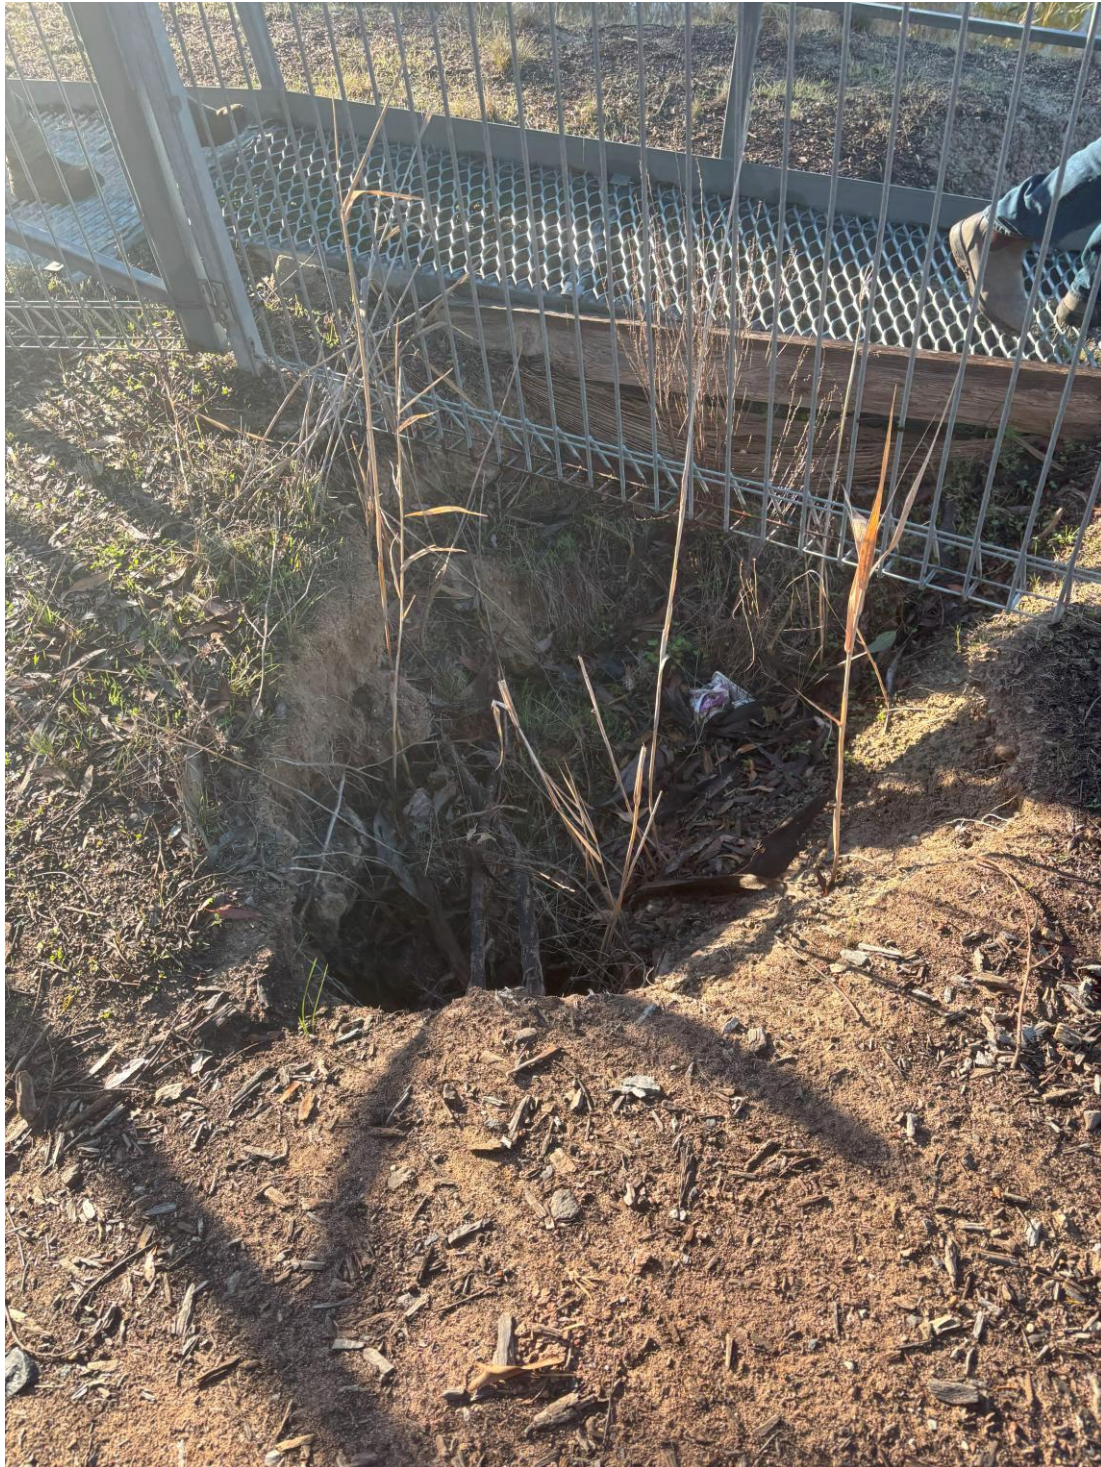
**Photograph 9 – Erosion along the entry fence line.**

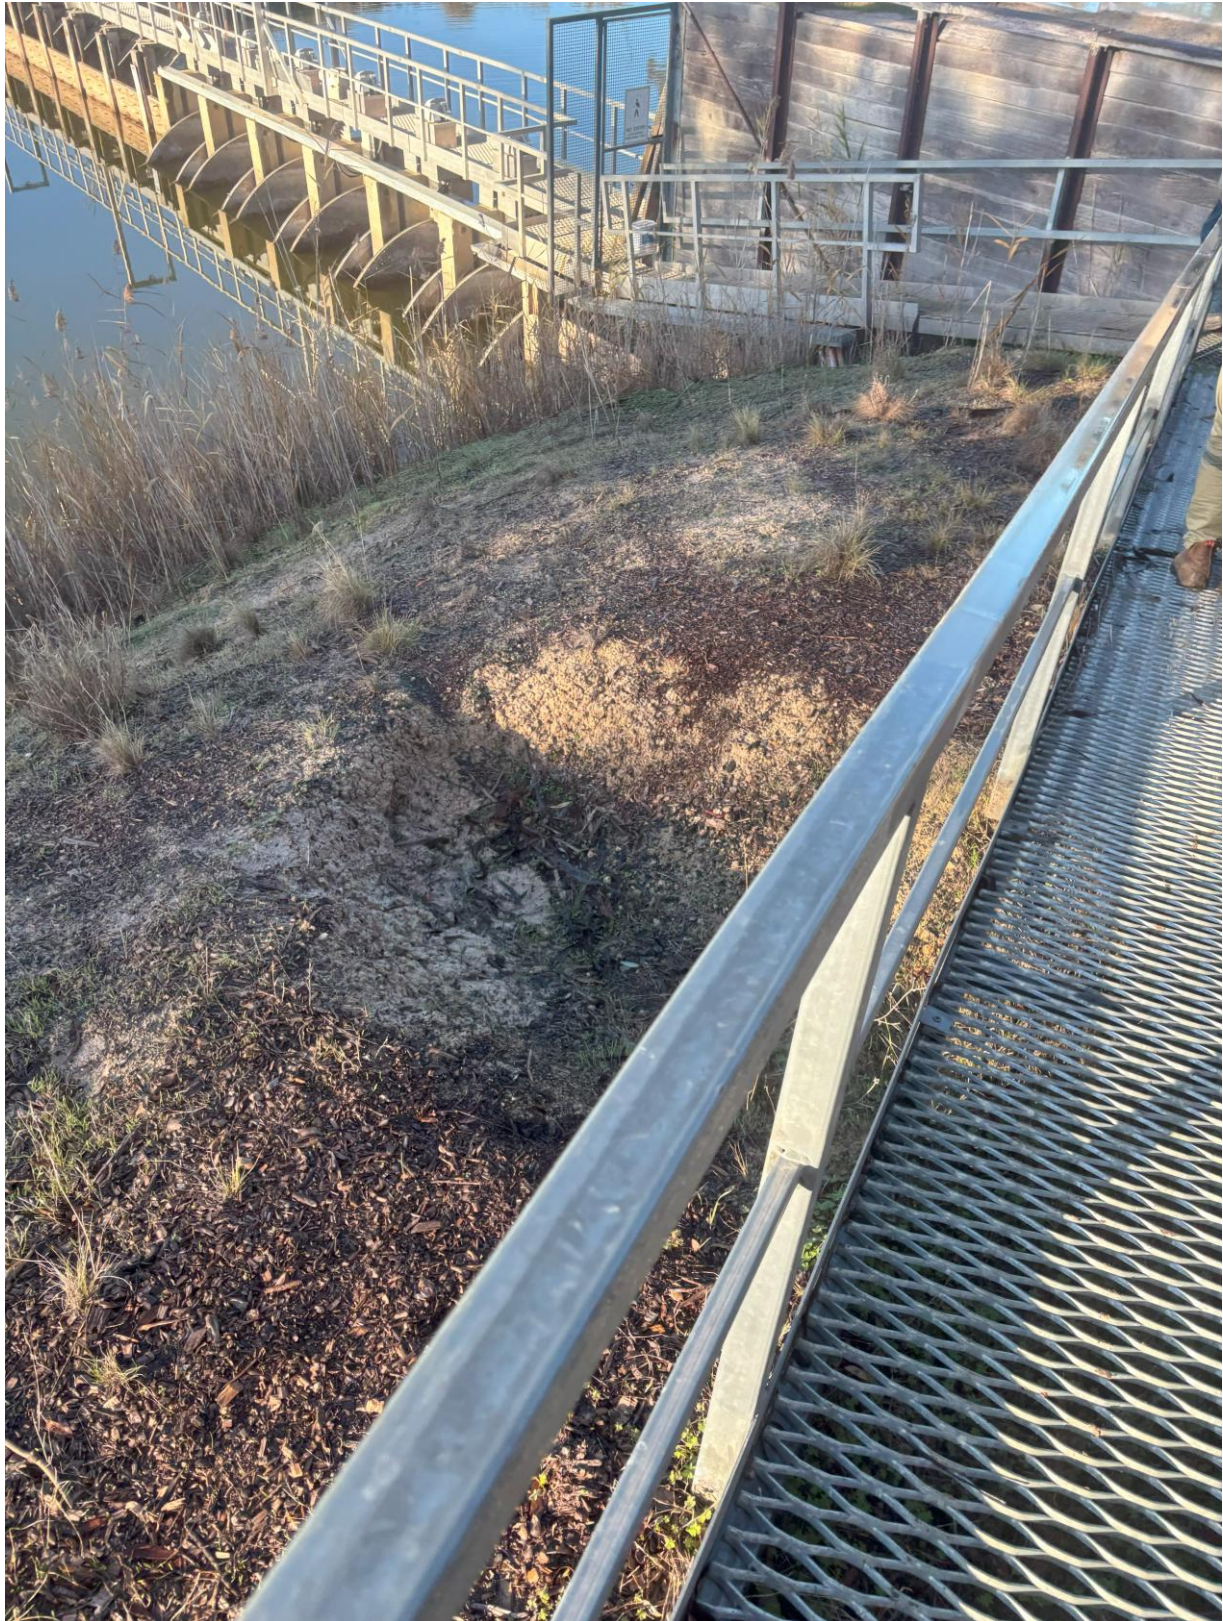
**Photograph 10 – Continuation of the erosion along the entry fence line.**

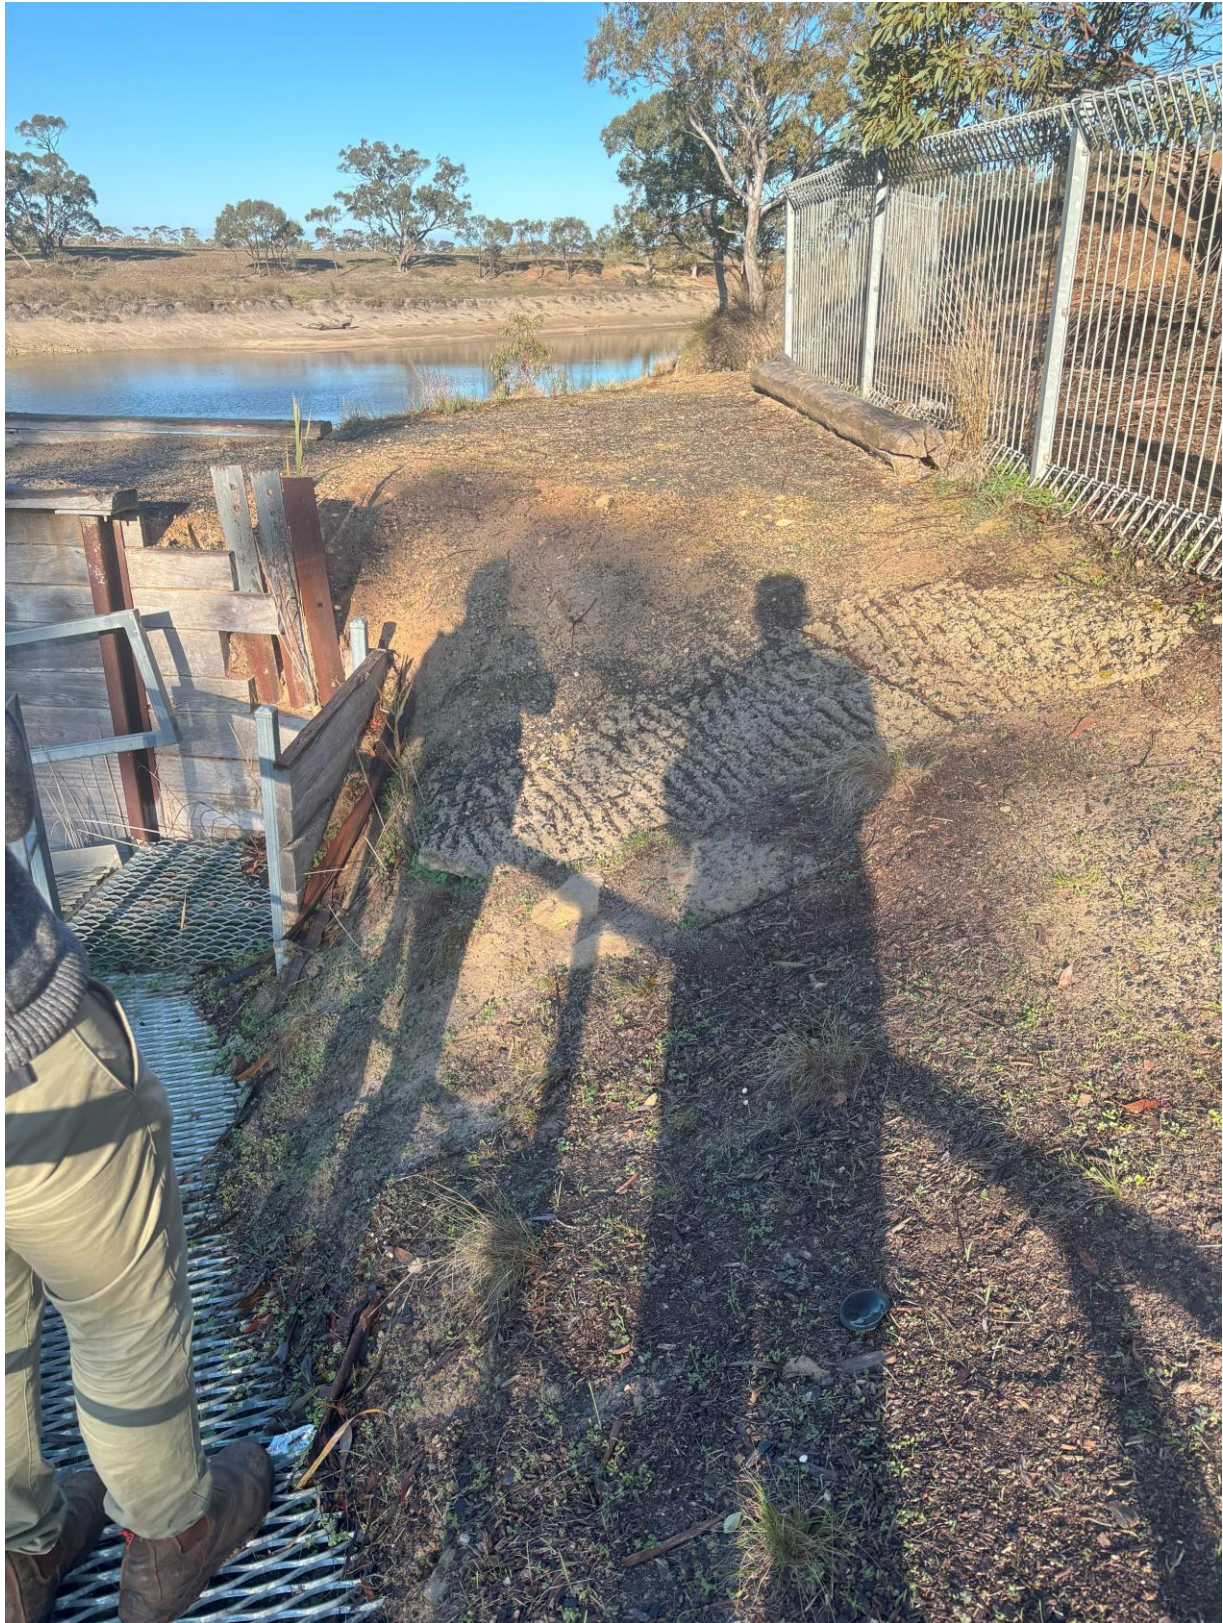
**Photograph 11 – Right abutment and retaining wall.**

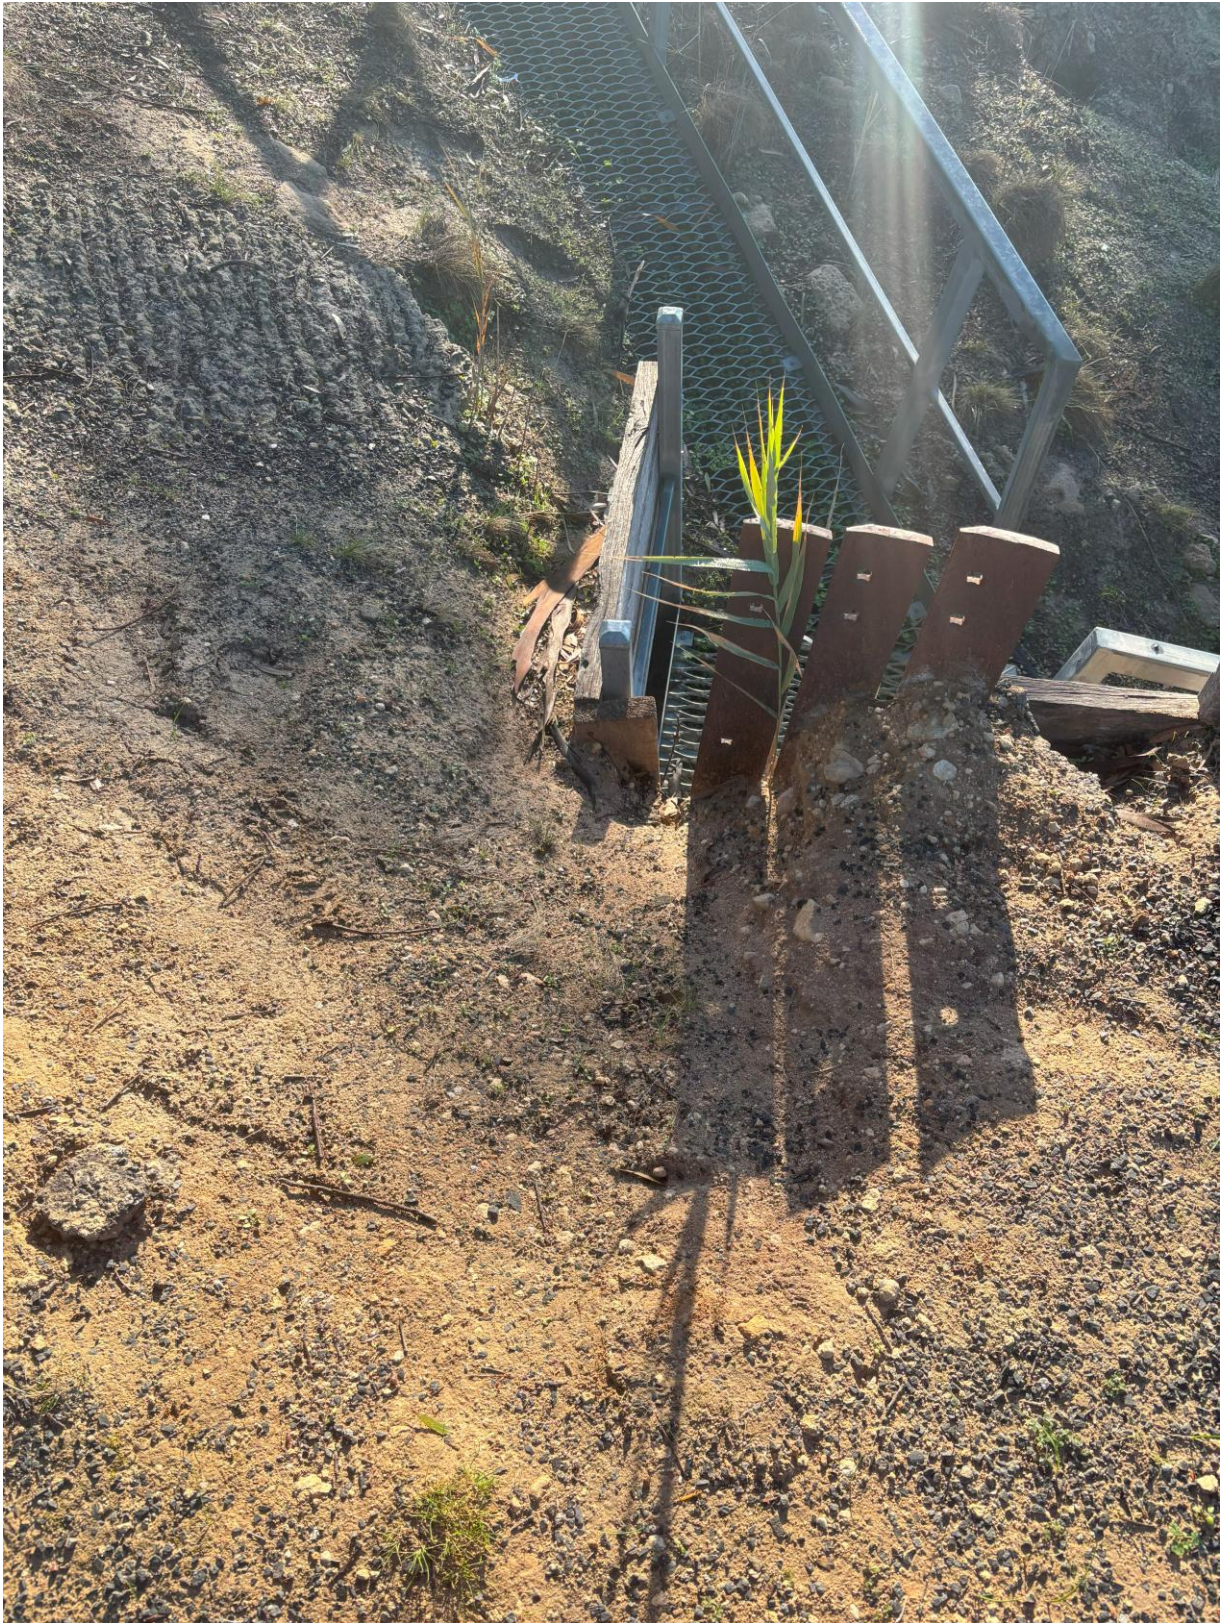
The right side of the abutment was inspected in more detail. Damage to the retaining wall was evident on all sides of the abutment, this damage was mostly specific to the timber boards. Erosion on this abutment was observed to impact all sides and the top of the abutment. The top of the abutment had signs of erosion developing in the corners of the retaining wall. Poor drainage on top of the abutments has led to erosion on the top surface of the abutment and also led to the formation of drainage channels which drain back towards the river, as shown in Photograph 12.

**Photograph 12 – Right abutment.**

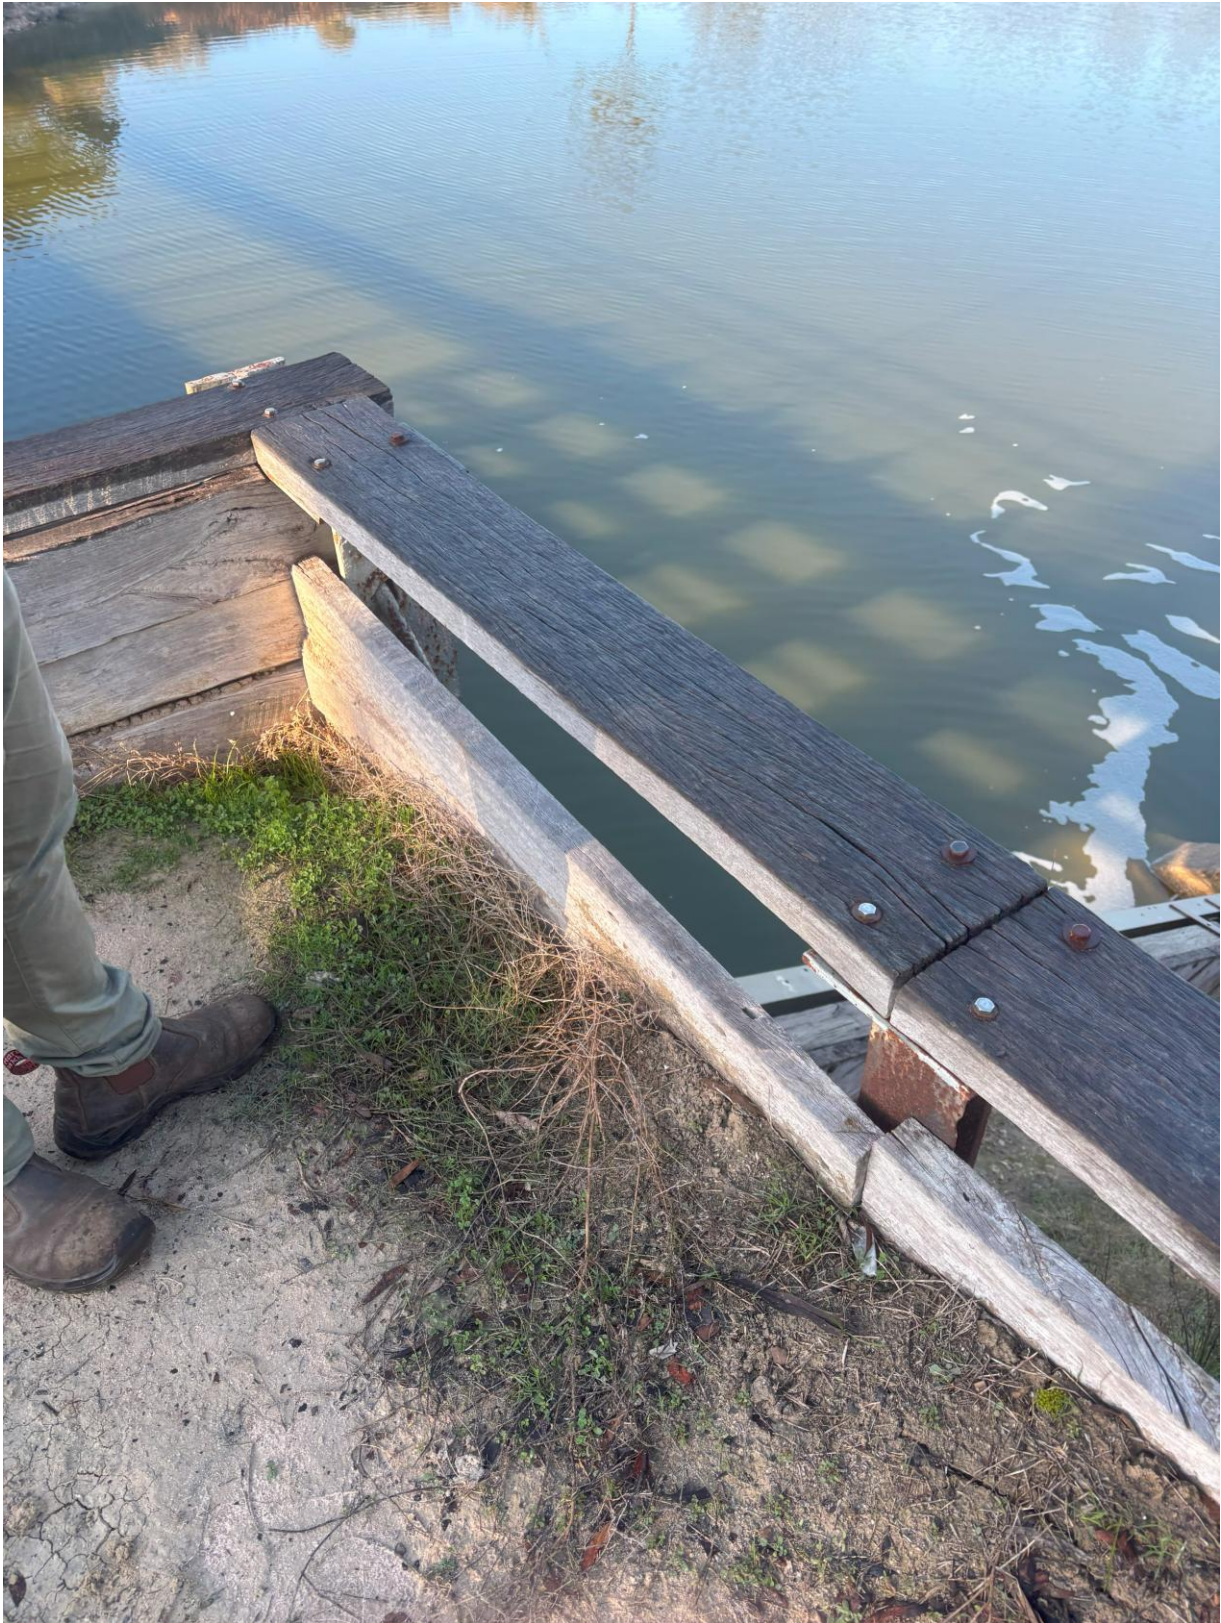
**Photograph 13 – Right side retaining wall and abutment.**

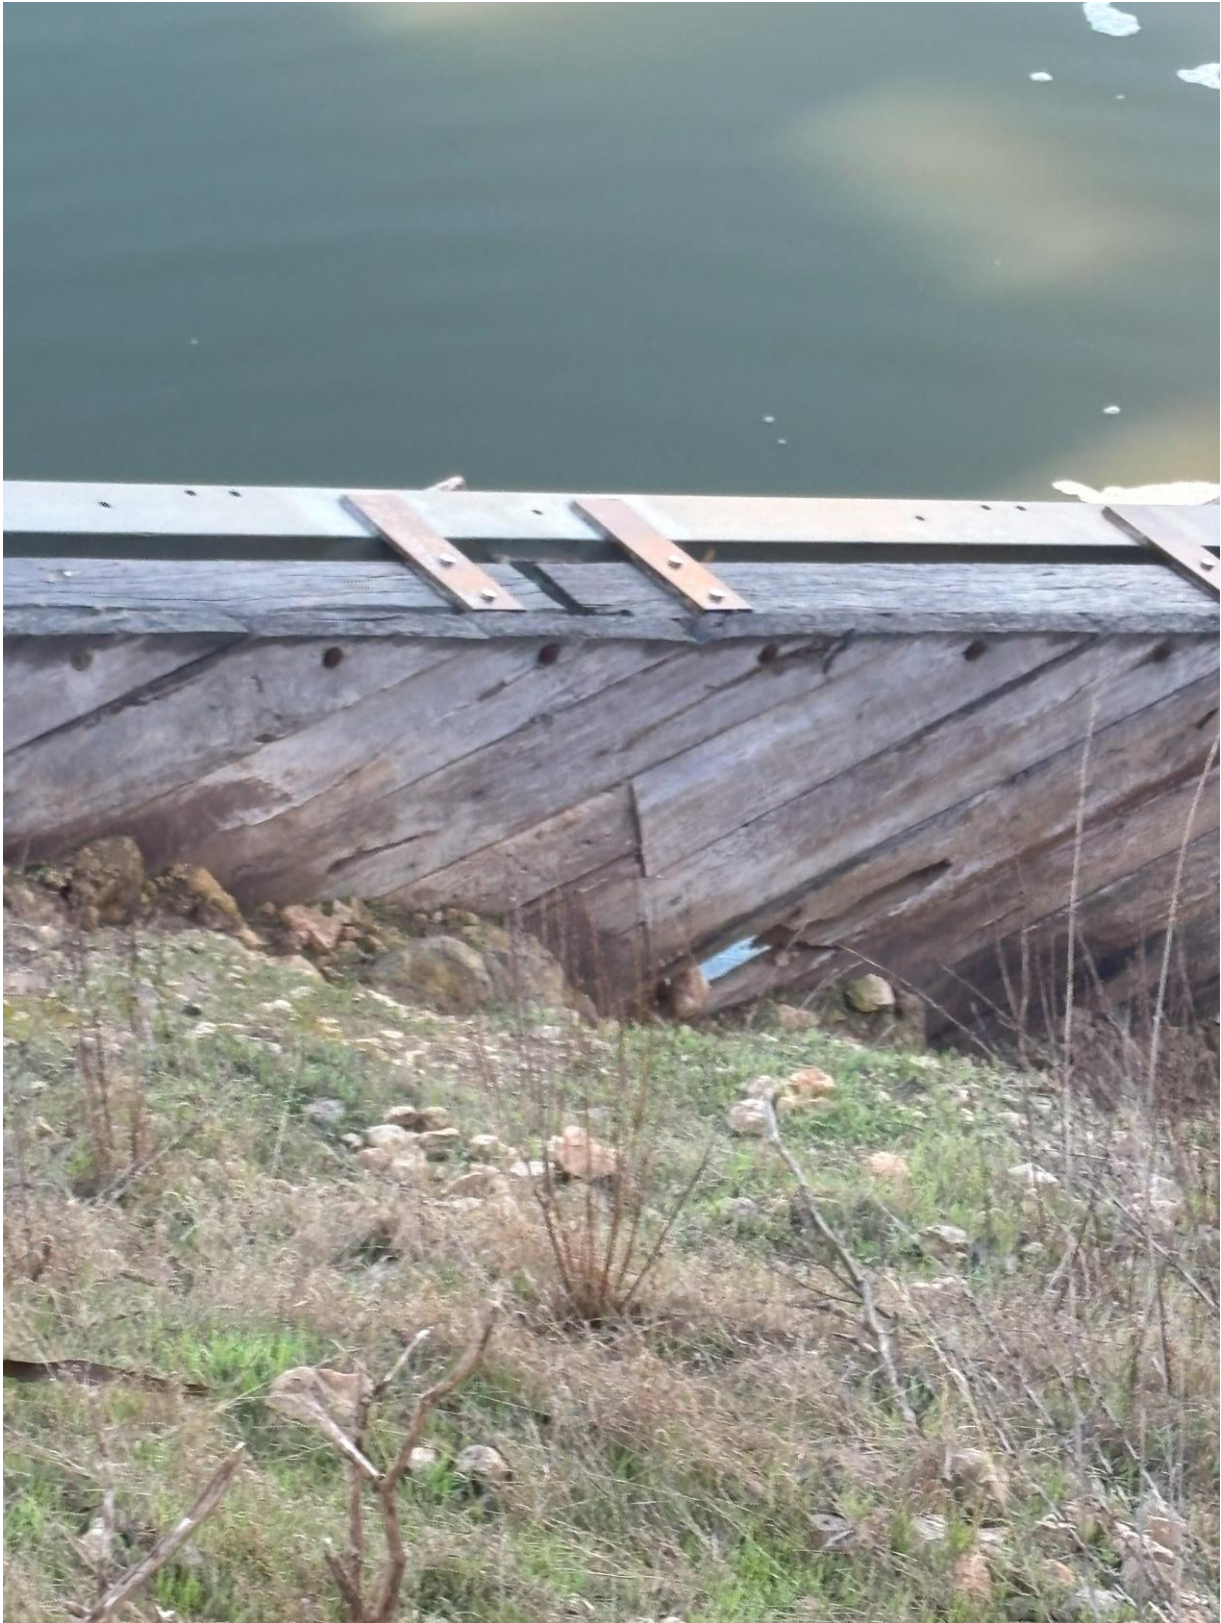
Photograph 14 – Right side retaining wall.
