# Redevelopment Overview

## Jeparit Weir Replacement

Hindmarsh Shire Council

28 February 2026

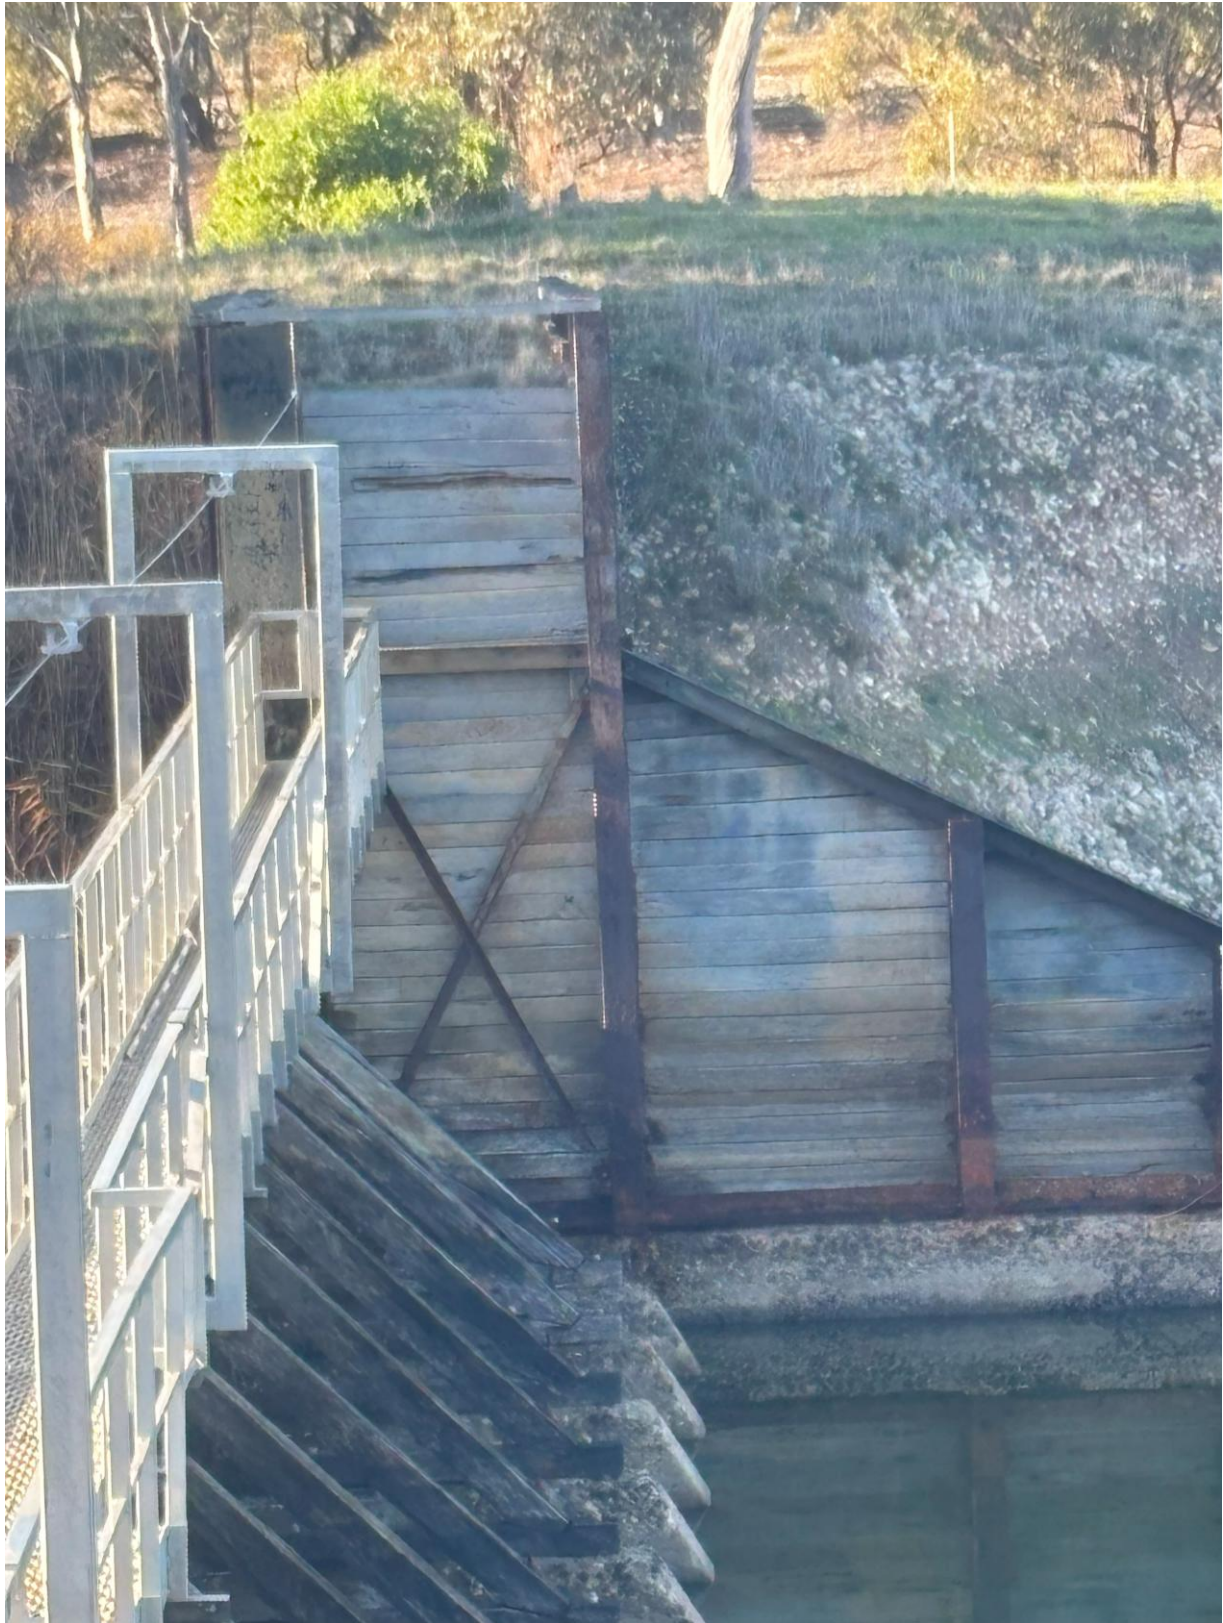
**Photograph 15 – Left abutment.**

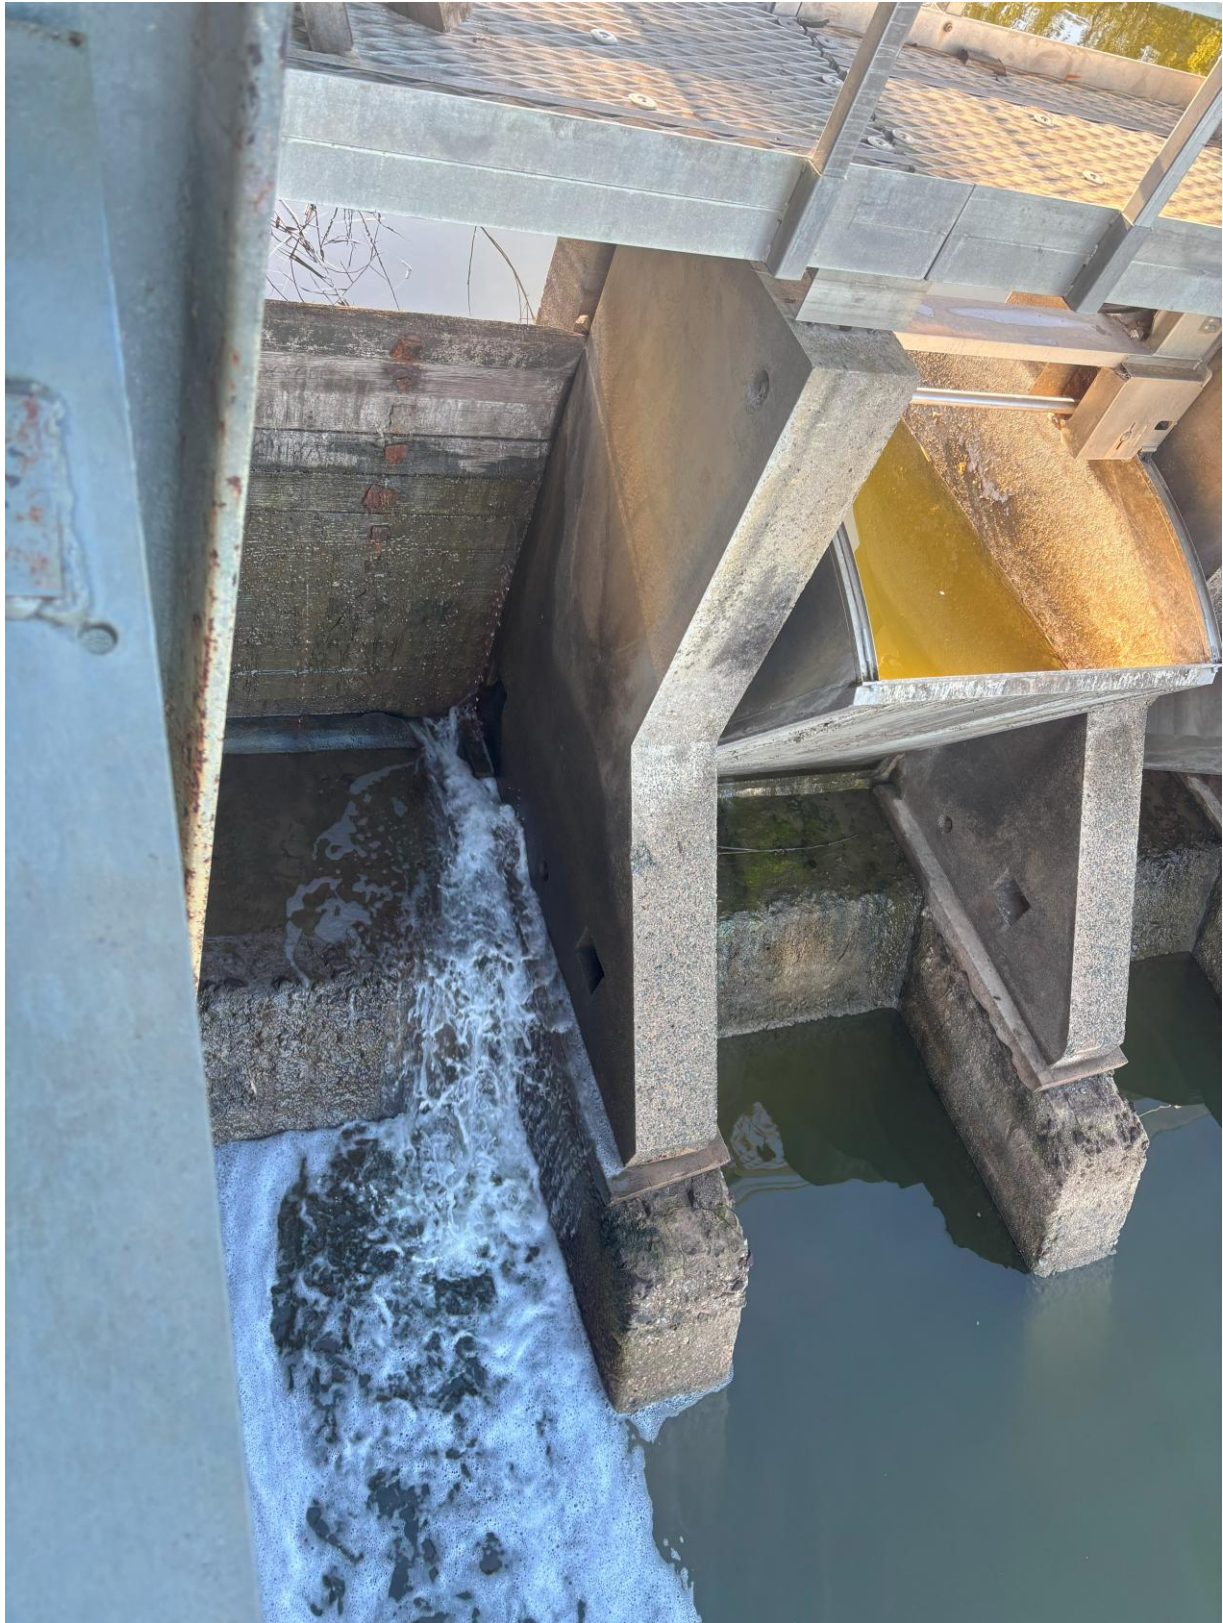
**Photograph 17 – Right most bay.**
